State of Wisconsin \ DEPARTMENT OF NATURAL RESOURCES

February 25, 2009

The Department will attend the Milwaukee County Parks, Energy and Environment Committee meeting on March 10, 2009, to answer questions regarding the Estabrook Dam. Estabrook Dam has several issues that need discussion and resolution. Each is described below:

**Estabrook Dam (Field File # 40.08)**  
**Summary of Work Schedule**

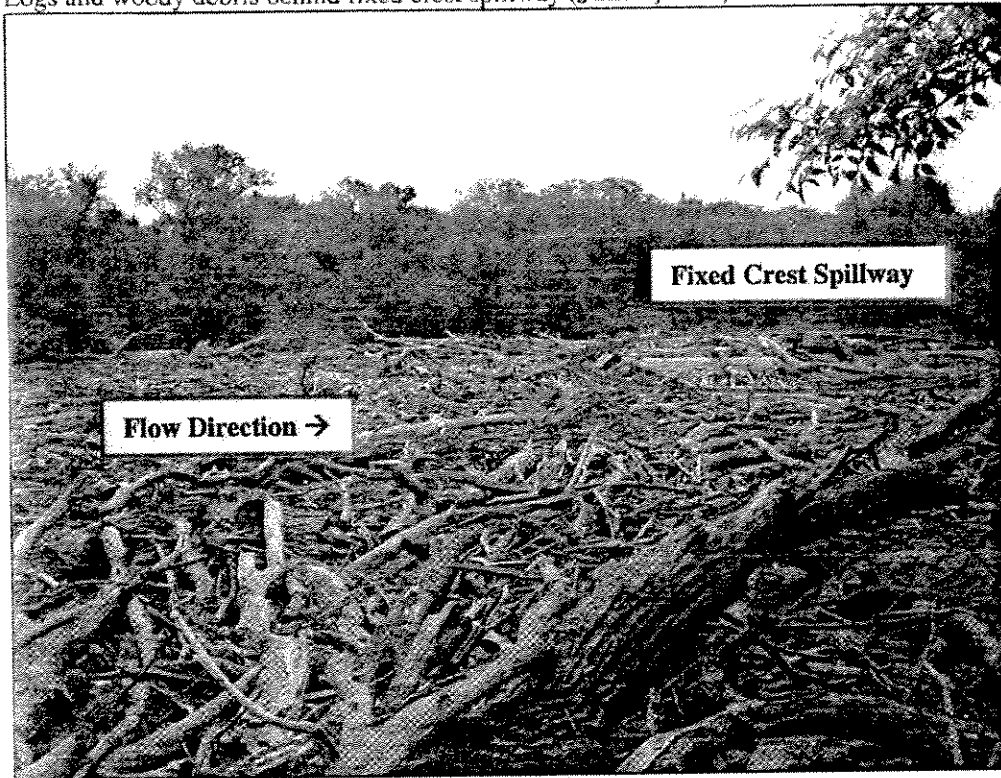
- The debris on the fixed crest spillway reduced the hydraulic capacity of the dam and the dam is not functioning as designed. Photos documenting the debris build up are attached.
- An Inspection, Operation and Maintenance Plan must be completed for Estabrook Dam. An Inspection, Operation and Maintenance Plan is required for all large dams (Wisconsin Administrative Code, Chapter NR 333.07(4)). This plan provides the dam operator with basic guidelines for performing routine and annual safety inspections, documenting the inspections, operating the dam within established water levels, and performing scheduled maintenance. It also provides a more comprehensive estimate of the annual maintenance budget for County staff and officials.
- Substantial concrete repairs are needed on the ice breakers, the dam gate walls, the bridge deck and the stoplog section piers.

Logs and woody debris behind fixed crest spillway (June 3, 2008):

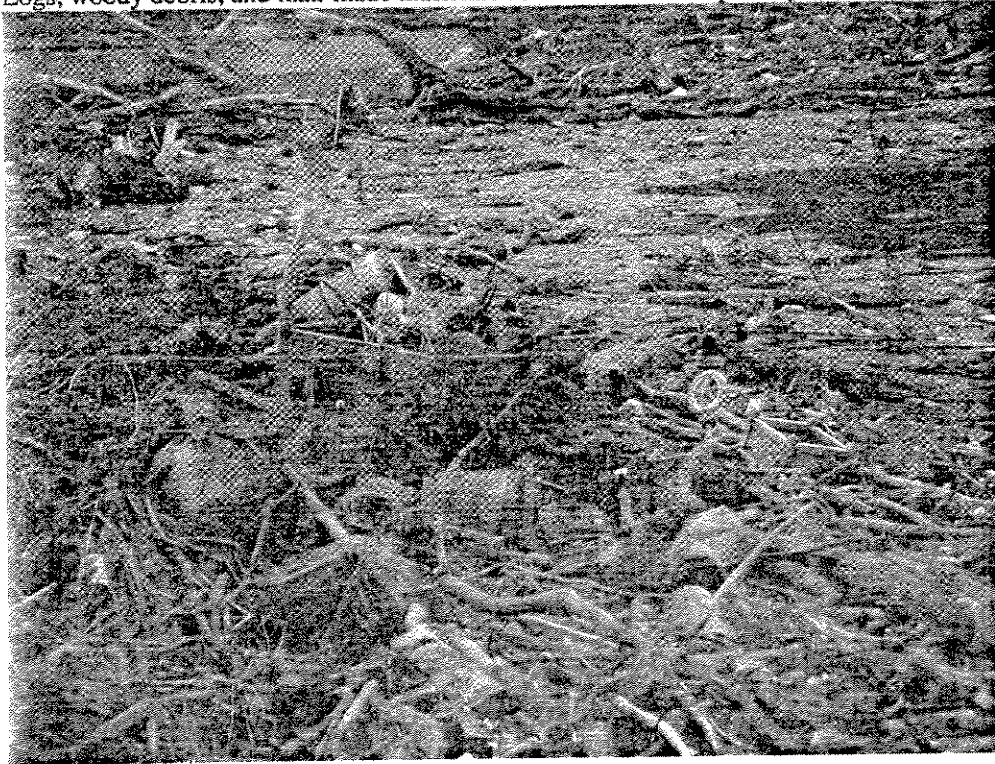
Logs, woody debris, and man-made materials behind fixed crest spillway (October 27, 2004):

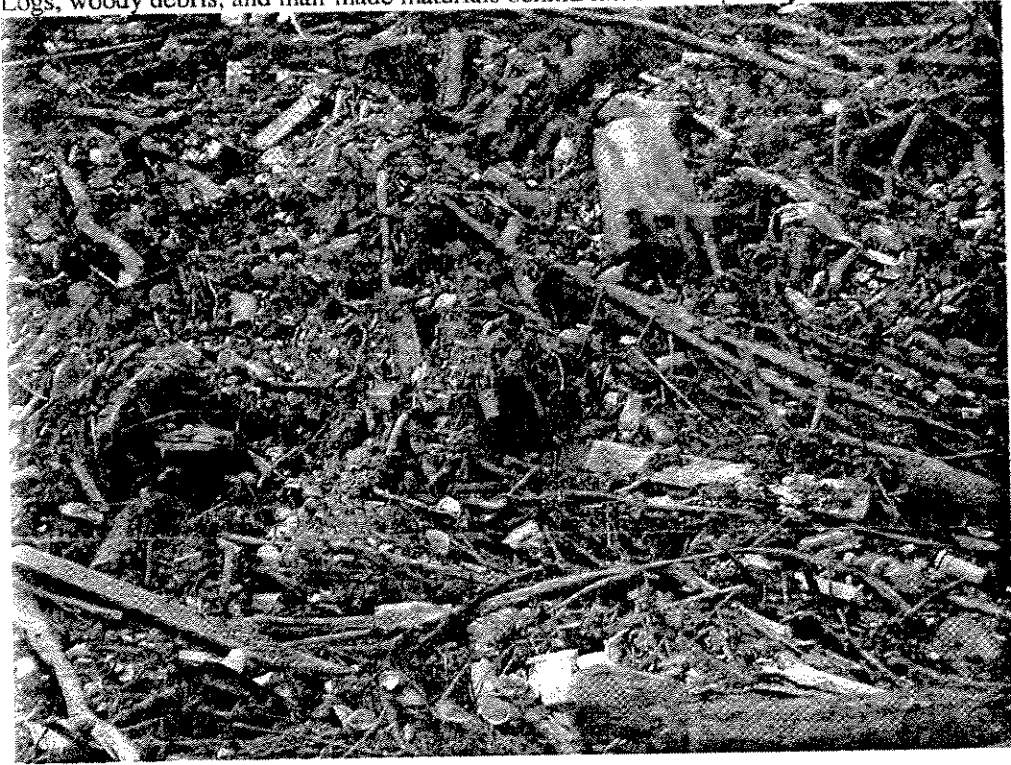
Logs, woody debris, and man-made materials behind fixed crest spillway (November 17, 2000):

4. Greg Young of your staff has contacted Will Wawrzyn regarding the need to remove a large amount of debris which has accumulated behind the dam and spillway. Access from shore is difficult and the County is considering burning these debris. While a large portion of the debris is wood, there may be a fair amount of man-made debris as well. Burning these debris may or may not be appropriate.
